PROJECT:

Preventive Conservation of the Collections of the National Museum of Bosnia and Herzegovina in Sarajevo

2015
-
2022

Commission to Preserve National
Monuments of Bosnia and Herzegovina

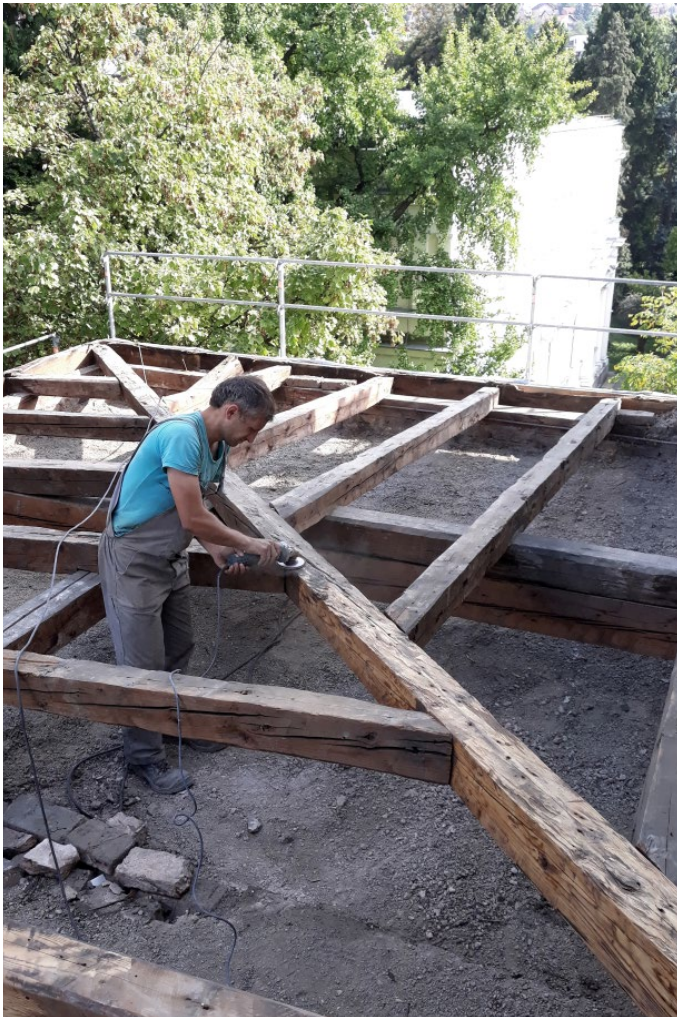
Photo 8: Restoration of the roofs above the Prehistory Section, Neimari. d.o.o. Sarajevo

The pavilion roofs of the Archeological Department and the Department of Natural Sciences suffered a considerable damage after the last renovation in the late 1990s, especially after heavy snowfall in 2012, and therefore their restoration was of a great importance for both the Museum buildings and its collections. (The Commission to Preserve National Monuments, 2015) One of the Project outcomes was the development of *the Main Project of Restoration of roofs of the Archeological Department and the Department of Natural Sciences, and the restoration of the concrete balustrade fences on the terraces of the complex in the National Museum of Bosnia and Herzegovina*. The main Project involved a technical assessment of the roofing of the Archeology and Natural Sciences pavilions; development and design of the project of roof restoration with all its elements (the roof structure, skylights, balustrade roof fences). (ArhiPlus, 2016) In order to improve the quality of the roof cover, which was originally made of zinc and later of galvanized sheet metal, the Head of the Project and the team experts agreed to use the zinc alloy with titanium and copper inset in a lower ratio. They opted for the zinc roof cover due to its features: flexibility during the building process, corrosion resistance, unusual durability and reduced need for maintenance.

The works on the roof restoration included the replacement of damaged wooden framework structures, repairs of the roof base carrier and racks and roof rafters, and the replacement of the boarding and the wooden roof cover. Below the zinc roof cover, the appropriate waterproof vapor permeable foil with tri-dimensional plastic net had been placed. This net allows the roof ventilation that prevents white corrosion on the roof cover. Beside the roof cover, the replacement of gutters was done as well as installation of the lightning rods, cleaning, galvanization and re-building of the already existing snow-

stoppers. There was restoration of the roofs marked with sign 01, 02 and 03, matching the roofs above the Prehistory Section, i.e. the east wing of the Archeological Department pavilion. The works were carried out and completed by the Neimari d.o.o. Company Sarajevo, under the supervision of the IG d.o.o. Institute of Engineering, Banja Luka.

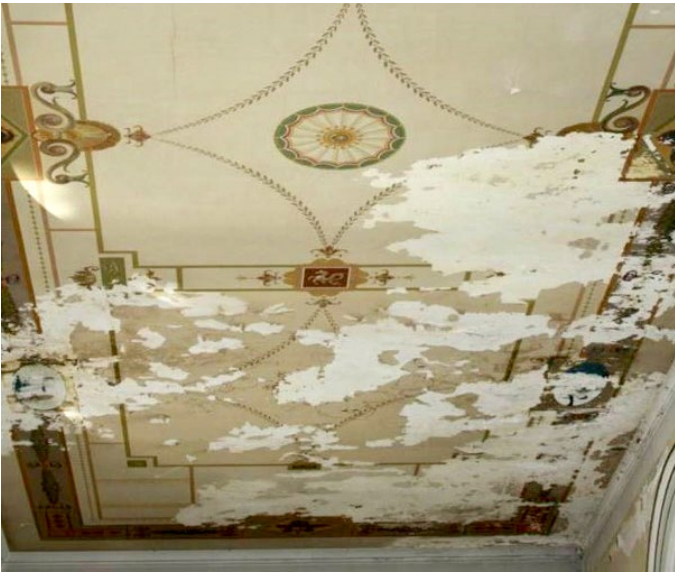
Photo 13: Restoration of the wall and ceiling paintings in the Prehistory Section, Commission to Preserve National Monuments

Esad Vesković, the Head of the Restoration Department in the National Museum, did the Feasibility Study for the interior restoration. Due to the roof and windows damage and water penetration, the ceiling areas were mostly affected. Mortar, which supports painted surfaces, was in a relatively solid condition, but it needed stabilization on certain surfaces, while in many parts the painted decoration was missing. The

painted layer started to peel off and lose its color-tone value and, in some places, it started to fall off. In the corners of the decorative fields, there was shading of the hue tonality. Architectural plastic was well preserved with a few existing minor cracks. (Koto, 2019)

The restoration works on the ceiling painting were done in 2018 and 2019. Due to a longtime exposure to unfavorable microclimate and war damage, the valuable ceiling painting with the motifs belonging to the Secession (Art Nouveau) decorative program sustained a considerable damage. In order to preserve and restore the visual integrity of the painted decoration, the acts of conservation, restoration and the partial reconstruction of the painting compositions on the areas of ceiling in the ground floor hall, the access corridor, the staircase ascending the first floor, the gallery on the first floor and the walls below the glass ceiling, were done. (The Commission to Preserve National Monuments, 2019)

Beside the previous research works on the stability of the base, materials and trial conservation procedures, the works included: mechanical cleaning of the layers of impurities by dry procedure, fixing of the unsteady painted surfaces (before mechanical cleaning) with acrylic, repeated where necessary, affixing the damages on the painted surfaces, replacing unsteady mortar base with the new one, the reconstruction of the missing parts of the painted layer modeled after the existing one. The drawing was completely transferred onto the prepared base by art calques and template models taken from the existing painted surfaces.

Retouch of the painted layer was done on the minor damages following the rule of not overriding the original. All the damage, such as cracks and holes have been filled with the material modeled after the original. Damages on the larger surfaces in the central part have been straightened and painted with an appropriate primer in order to obtain the base that can evenly absorb the paint. The restoration of all gold-plated surfaces on the arch-like wreaths was done. (Koto, 2019)

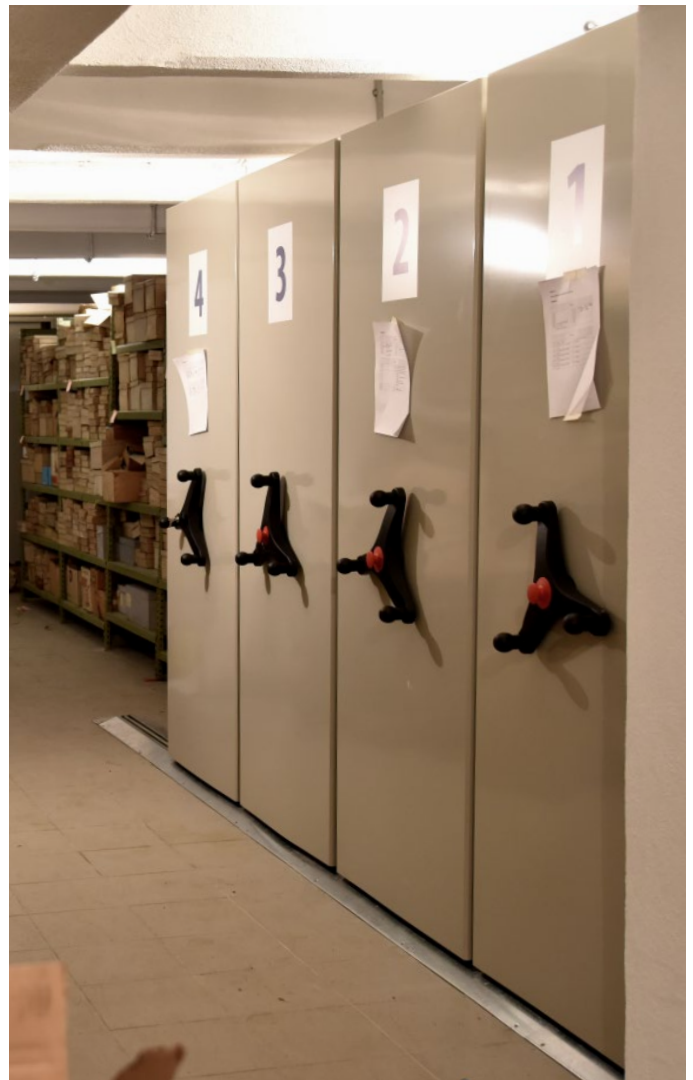
Photo 17: Restoration and equipping of the depots, Ideologija, Sarajevo

The works on modernization of depots in the pavilions of the Archeological Department and the Department of Natural Sciences were carried out and completed in 2019. The depots for artefacts safe-keeping and workshops are located in the basement of the pavilions. The works on restoration and equipping were done for 11 premises and corridors - 790 m² in total, including the laboratories for taxidermy of vertebrates, the depots for safe-keeping of amphibians, reptiles and fish, the Ethnology and Archeology depot, as well as the restoration of corridors. The sanitary block was constructed and set up on the ground floor. Along with the restoration of the depots, the electrical installations were done, the lightning fixtures were set and toilets were built in. The area has been equipped with 8 movable display shelves and sliding doors for front closing and safekeeping of the materials, while lockers with drawers for textile storage were put in the depot of the Department of Ethnology.

The works included sanitation of all storage areas: floors, walls and ceilings. Walls and ceilings have been plastered and whitewashed (1900m²). The new anti-skid tiles were put as well as the streed on the floor (509m²), except in the room with

wooden parquet, which had been restored. The restoration of the depot on the ground floor of the Pre-history Section was done, as well as the restoration of the metal staircase with the wooden treads and the mid-floor where the office was set up. In this area, the restoration of the existing (9) massive wooden closets was carried out. The closets are of a simple design without ornaments, while the design solution reflects a tendency towards the functionalism from the beginning of the 20th century. Metal glazed showcases for deposition and display of the sepulcher and anthropological material were made. After the completion of the building works, the depots were equipped with the modern closets for safekeeping of the Museum holdings and property.

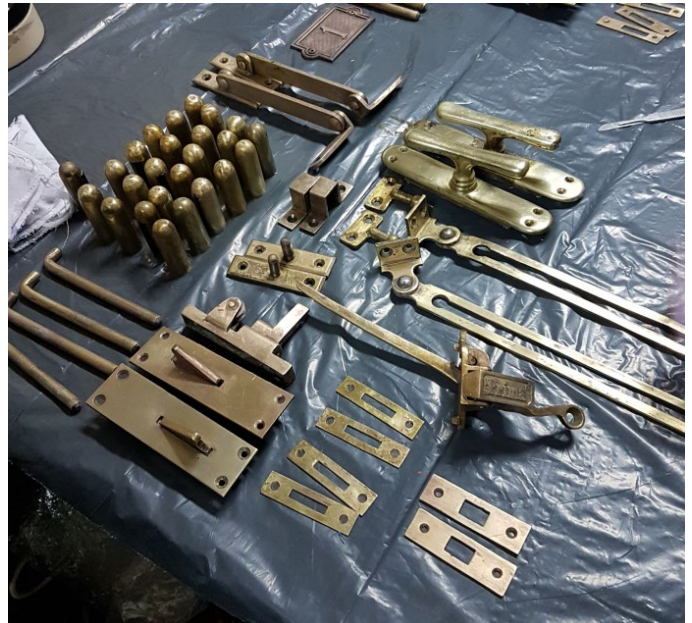
Photo 20: The partial restoration and replacement of the wooden window frames and doors, Commission to Preserve National Monuments

Windows and doors in the Natural Sciences pavilion are from the period when the edifice was built, more than 110 years ago. Windows were made of oak, most of them twin double-winged with upper ventus, except for the fixed single-winged windows that end up in a semi-circular form and which are set on the striking square blocks. All the windows are single glazed. In the fixed arched stone window luminous outward openings are of dimensions in the range from 225 to 232 cm and from 390 to 405 cm, while twin double-winged windows with ventus (ending up in a rectangular and arch form), the luminous outward openings are of dimensions in the range from 140 to 154 cm and od 300 to 309 cm. On every side of the entrance door, one double single-winged window with a lunnete of an origin-changed shape was set (it was probably completed in an arch shape). Inside, the exhibition halls on the high ground floor on the north side are adapted to the needs

of the depot and the restoration workshop; they are partitioned with mid-floor structures on two storeys while the original windows were kept but couldn't be opened because of the partition. Poor condition of the windows and the doors allowed the penetration of the water into the objects, which resulted in a higher level of humidity and decay of the collections. Furthermore, the windows didn't meet the conditions of energy efficiency. (The Commission to Preserve National Monuments, 2018 (2)) The initial approach was to restore the windows along with setting an appropriate window sealing gasket, and to replace only those positions which are in a poor condition and which cannot undergo the restoration treatment.

The Feasibility Study of the partial restoration of the windows and doors in the Natural Sciences pavilion, done by the Urbing d.o.o Company, Sarajevo, analyzed the state of each of the joinery positions. The Study proved that the windows were in an extremely poor condition – that they were 110 years old, neglected, damaged by acts of war in the 1992 – 1995 period, partially rotten and deteriorated, the hinges removed, while most of the windows were later fixed so that they could no longer be opened. (Urbing, 2020)

Workshop draft and sketches were made for each position and according to it, 42 windows were replaced. Sketches for lateral surface finish for different window positions were also done. Double windows on the north side, which could not be opened, due to the mid-floor structure, were replaced with single windows with ventus and insulating glass (IZO glass), which enabled their opening. The new windows were made of the glued oak elements, finally impregnated by the submersion with the addition of the chosen water-based wood stain and final ecological colorless matte varnish, appearance and dimensions of which were modeled on the existing ones.

As the best preserved, two windows on the north side were chosen for restoration, singly in the middle of the indented part of the facade on the left and right side of the entrance. The works of replacement and restoration of the joinery were carried out and done by the Koto Joinery Workshop Company Banja Luka, the restorers were from Koto d.o.o. Belgrade, and the Fagus Company Banja Luka did the windows manufacturing. For the joinery restoration and the restoration of the entrance door, the following methodology was applied:

- After dismantling, all wings of the wooden windows were put away at the building site for the purpose of choosing hinges and other parts that required replacement. Given the fact that brass hinges were hand-made and custom manufactured, it was necessary to try out more models that were found on the existing windows. Window hinges and drip-rails were in a very poor condition and had to be replaced. The internal ledges were in a rather good condition and needed only minor renovation works. The window glass was replaced with the original existing glass from a dismantled window because of its cracks. Removal of the present impurities from the brass elements was done in the solution of sodium bicarbonate and acetic acid in warm water after a few trials. Neutralization was done in distilled water, while drying was done at a room temperature. After cleaning, brass elements were protected with the micro-crystal wax paste.

- On the wooden window frames and doors, the works were done in the following phases: cleaning surface impurities, filling in the cracks by putty method. Deeper damage spots were filled with binder and addition of wood sawdust of the same structure as the original wood. Shallow damages and cracks were closed

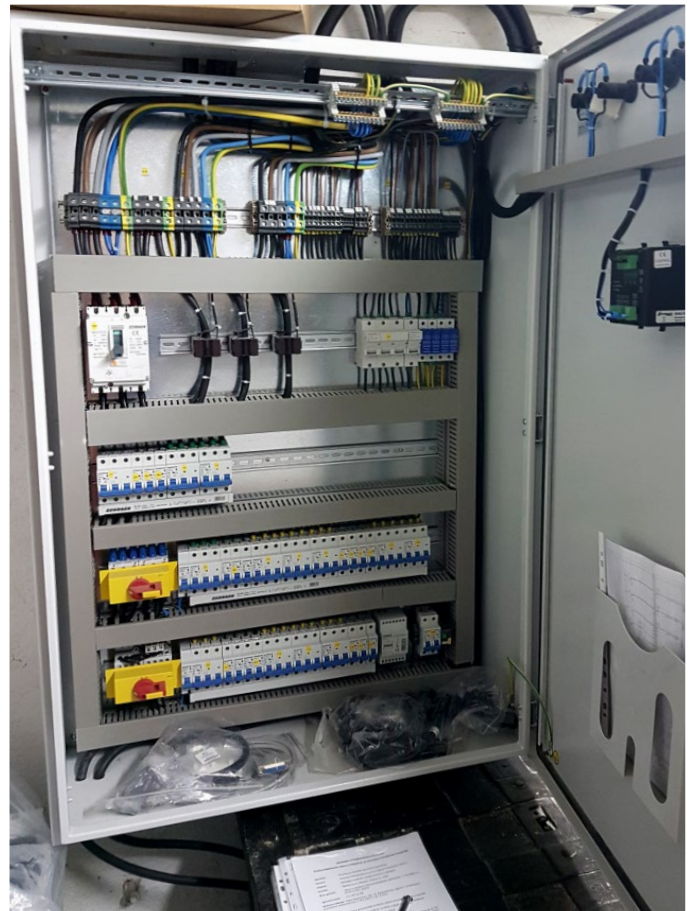
Photo 23: Replacement of the decrepit electric system, Ideologija, Sarajevo

In accordance with the available financial means and budget, and consultations with the Management of the National Museum of Bosnia and Herzegovina, it was agreed to replace the electric installations in the Department of Ethnology, which is, due to the textile and wooden items, exposed to the greatest fire risk.

According to the main Project, the works on installations of strong current were done with building in and fitting of four distribution boards and power cords, ensuring backup power, fitting of installations for illumination and electrical ports, installation for equalization of potentials in sanitary blocks and lightning rod installations and installation of the weak current in the integrated data nets. During the realization of the main Project, a change relating to the illumination was agreed. The number of the treated areas is reduced and the concept of illumination of the exhibition areas on the floor was partially changed. The decision was made that priority should

be the public space, communication space and exhibition spaces along with ensuring the representative and good quality illumination, while the basic illumination should be installed in the depots and basement. It has also been agreed to introduce the system of indirect illumination for the exhibition spaces on the floor in order to be a part of its set and to emphasize details. The idea about illumination of the wood-carved ceiling in the central staircase was abandoned because of high position of lights, maintenance of which would demand the scaffold usage. Instead, it was decided that decorative lights should be put on a lower position, which will attain and provide diffuse illumination of the staircase. Construction and finishing works preceded the work on electrical installations. They included both, chiseling off the ceiling and walls to set the cables and walls for distribution boards and their treatment after the building in process as well as painting the entire wall surfaces and ceilings. The works were carried out and completed by the Neimari d.o.o. Company Sarajevo. The constructor has been obliged to design and make the project of the carried out state of the electrical installations of strong and weak current, and submit the attestations. (The Commission to Preserve National Monuments, 2021)
